SERVICE BULLETIN REVISION TRANSMITTAL SHEET

TITLE: WINGS - GENERAL - ONE TIME INSPECTION OF TAPERLOK BOLT AT

WING TO FUSELAGE JUNCTION.

This page transmits Revision No.03 of Service Bulletin No.A320-57-1131

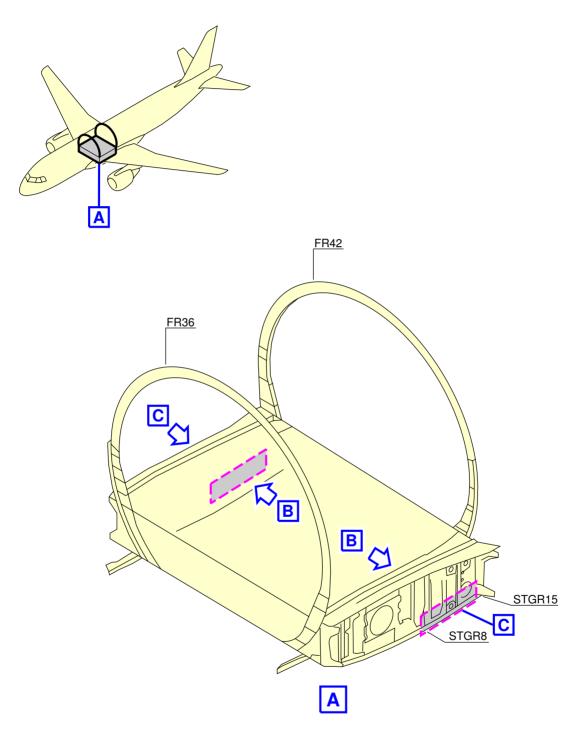
Figure A-FCEAA - Sheet 01
Inspection of the Fasteners for the ADDITIONAL WORK

The ADDITIONAL WORK consists in inspecting new fasteners located in the center and outer wing box in the Rib1 area.
